# Bathhouse Row Adaptive Use Program

The Superior Bathhouse: Technical Report

HOT SPRINGS NATIONAL PARK  
Garland County, Arkansas

June 1985

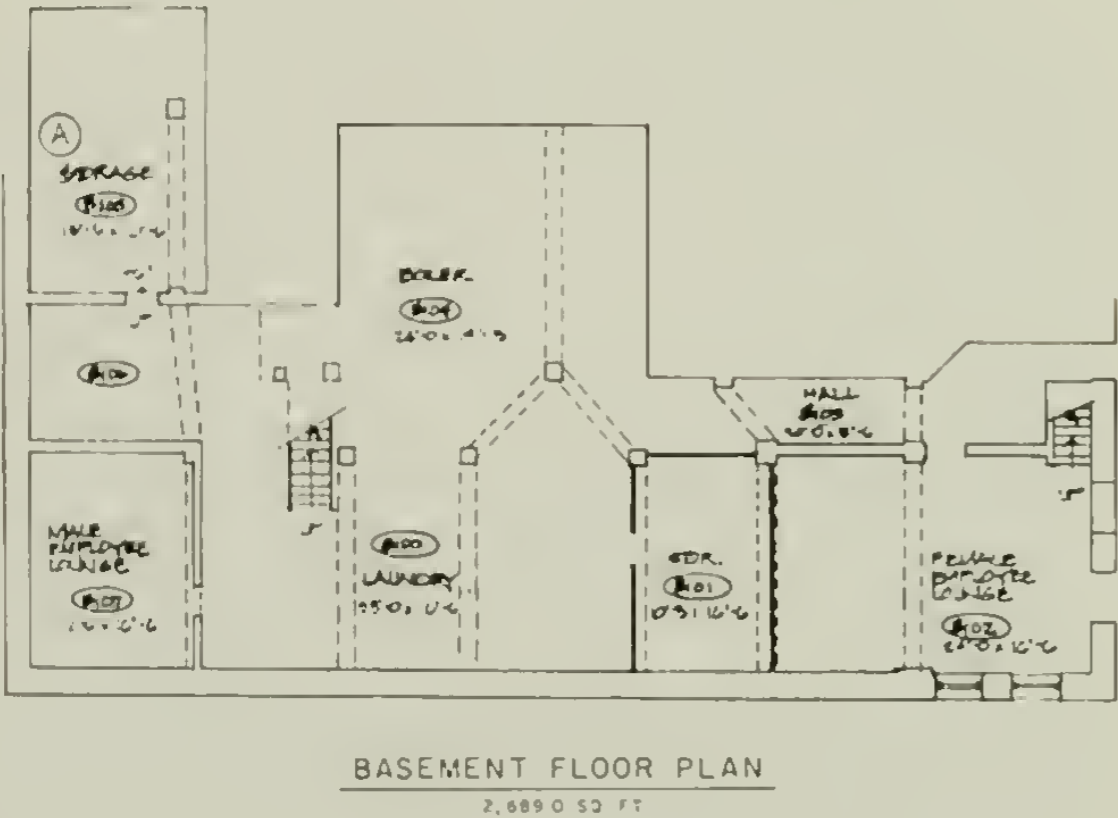
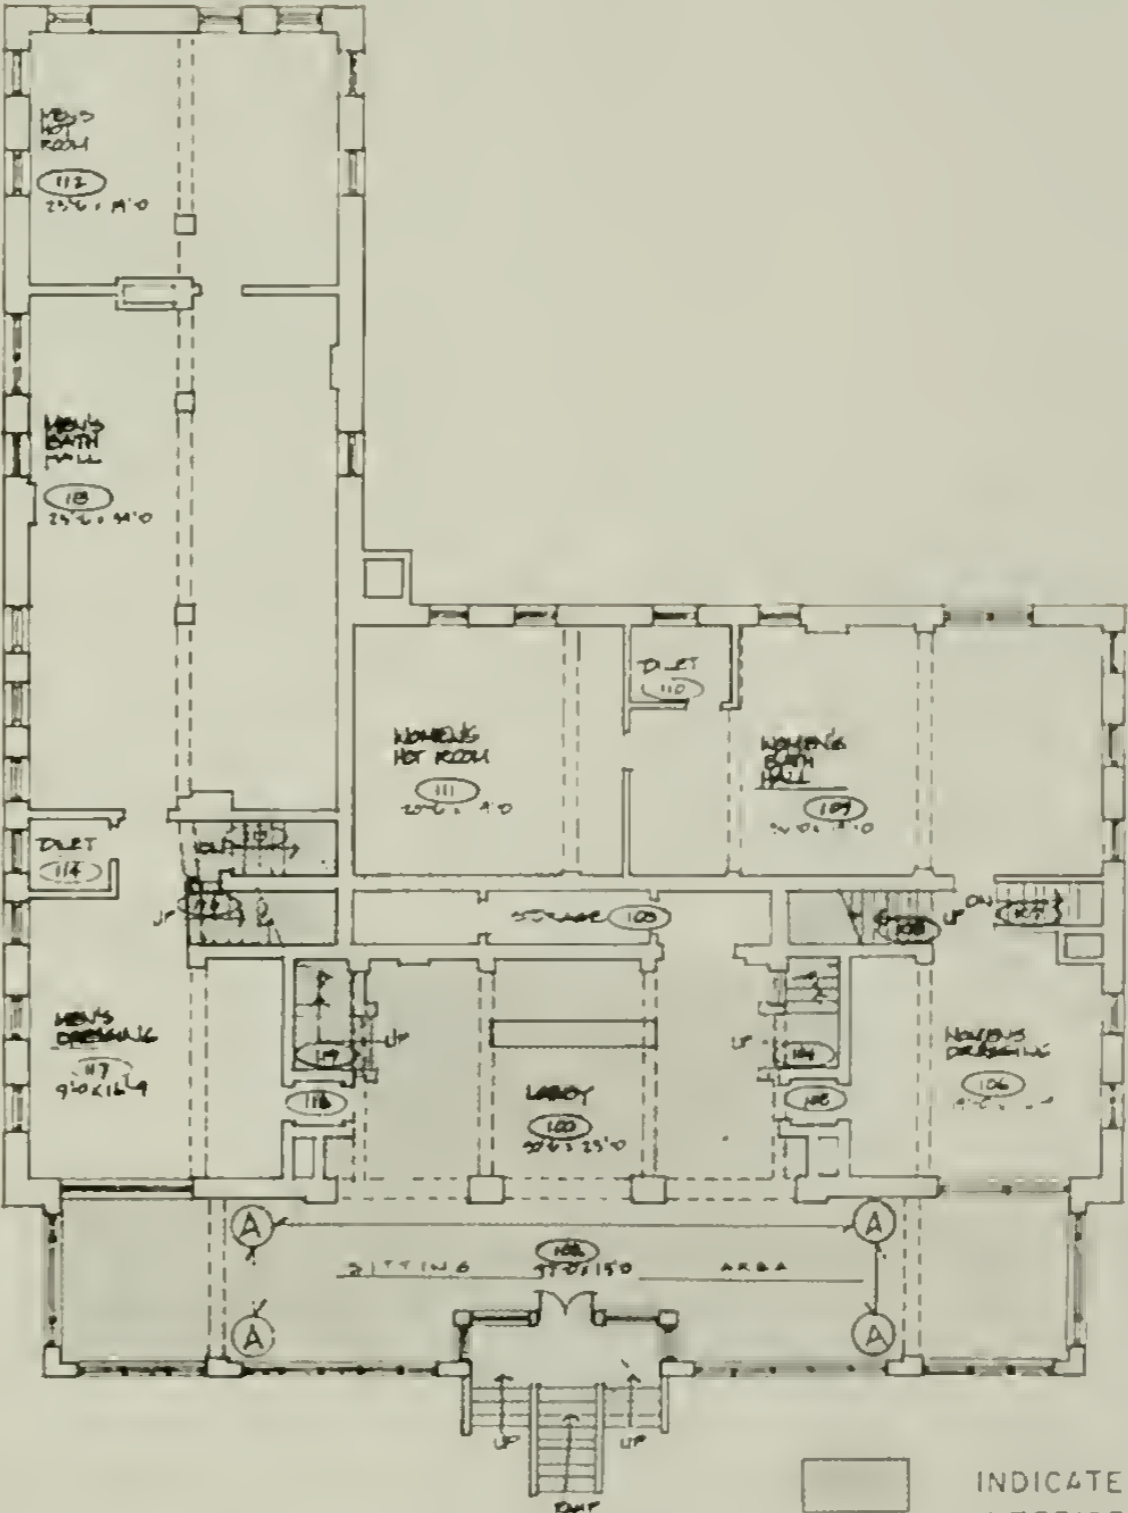
Figure 4

[Note: The capital letter symbols are cross references to the bathhouse floor plans, figure 4 and 5.]

<u>1973 Historic Structures Report</u>	<u>Investigative Study of Five Bathhouses</u>
Basement	A	Ceiling crack.	Stress-relief crack. Stable.
First Floor	A	Crack around sitting area.	This could be a settlement crack or a stress-relief crack. It looks stable and probably has not changed much since 1973.
Second Floor	A	Wall crack in a pattern which indicate settlement.	This is a masonry crack caused by the curling of the concrete slab. There is no indication of foundation settlement in the basement nor on the second floor.
	B	Crack near ceiling which extends the length of the wall.	These must be stress-relief cracks in the walls or caused by plastic creep in concrete supporting beam. The structural slab on both sides of this wall were load tested. Therefore, it is structurally sound.
